Manhole Inspection Summary

Manhole # S21CC1018MH

Location Address: **2017 DRUID PARK DR**

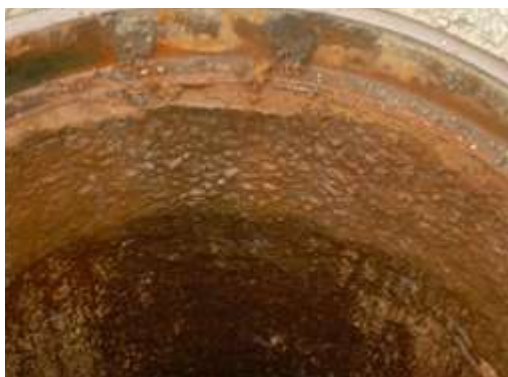
Defect

☒ **Leaks**

Infiltration: ☐ None ☒ **Joint** ☐ Cracks ☐ Mortar ☐ Roots ☐ Wall

Frame leaks. Adjustment infiltration.

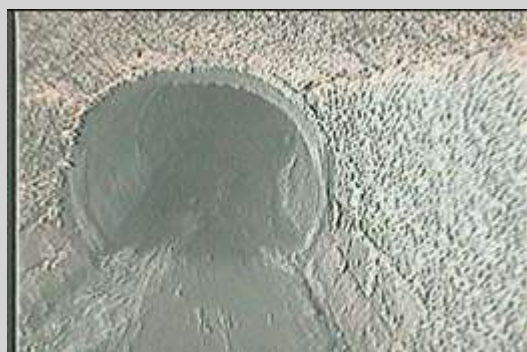
Pipe Out @ 12 O'Clock

15 in. Circular Gravity Sewer

Infiltration: **None**

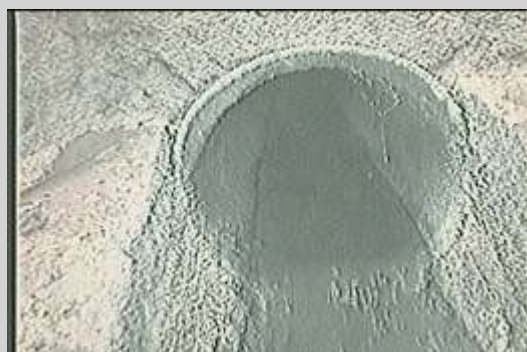
Pipe In @ 6 O'Clock

18 in. Circular Gravity Sewer

Infiltration: **None**

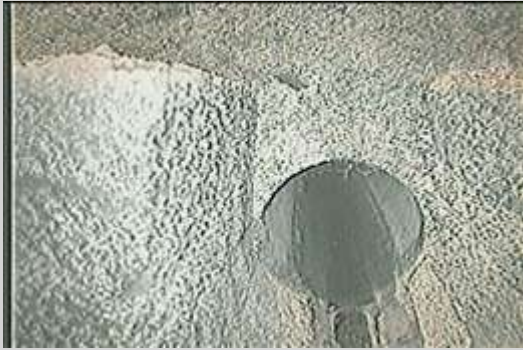
Pipe In @ 9 O'Clock

8 in. Circular Gravity Sewer

Infiltration: **None** Pipe Seal Cond: **Unknown**
